# Technical Service Bulletin MHTSB-2022-01

## Subject: Emergency Bypass Control Switch Upgrade

Replacement of the Exhaust-port filter fitting on the MH 2ip/4ip Emergency Bypass Control (EBC) Switch Assembly

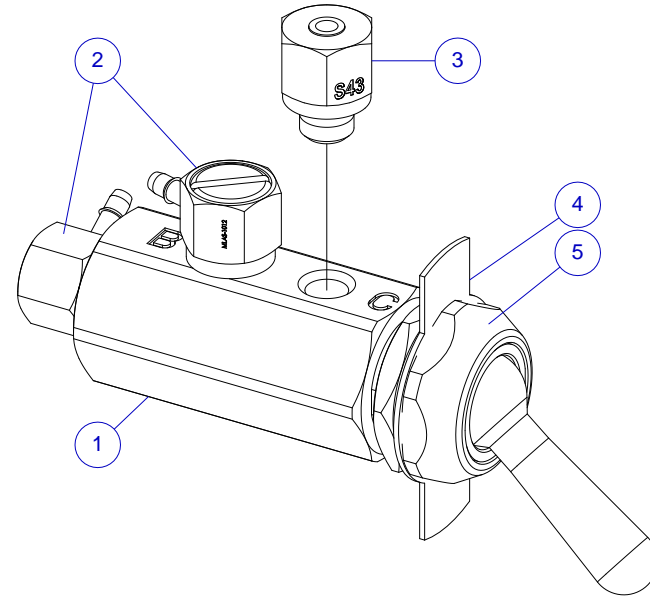
Under some circumstances the EBC outlet (4mm/Red tubing) of the remote regulator (IPR) may fail to shut off and oxygen will continue to flow when the EBC switch is cycled to the "OFF" position. This can be attributed to excessive restriction in the exhaust-port filter installed at Port "C" of the EBC Switch which prevents the control line from properly purging in the "OFF" condition.

Replace the exhaust-port filter with a less-restrictive one.

- Turn the oxygen system OFF before proceeding.
- You will need sufficient access to the EBC Switch (Item 1) to allow you to remove and replace the Exhaust-port Filter (3) installed at Port "C". In some situations you may be able to do this without removing the EBC Switch from the panel. Otherwise, remove the Dress Nut (5) and Legend Plate (4) and remove the EBC Switch from the rear of the panel.

- Remove the existing Exhaust-port Filter (3) installed at Port C and replace it with the new one provided by MH (5/16 Hex). If you have a suitable torque driver, torque the new fitting to 7 in-lbs - otherwise "snug" (do not over-tighten).
